25th
Anniversary

A Connecticut Yankee in Penn's Woods

(See our Spring, Summer, and Fall 2011 issues for the first three chapters in the saga of Tim & Cindy's house.)

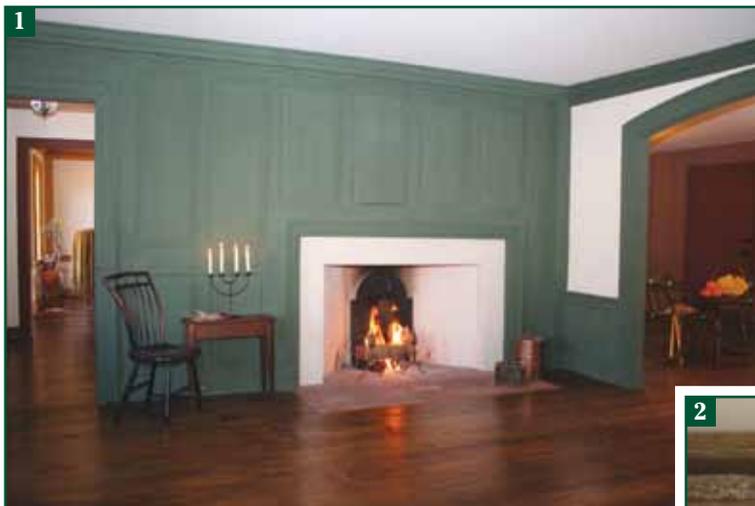
The original c.1788 structure had fireplaces in the primary rooms of the 1st and 2nd floors. Tim & Cindy chose not to rebuild the 2nd floor fireplaces. At some point in time, perhaps the mid-1800's, the residence was converted to a public tavern. During that renovation, the formal Dining Room (Photo #1) underwent some major changes. The shared wall between the Dining Room and the rear Keeping Room was opened up and what had been a partition wall with a door was replaced with a wide, open archway. The stately paneled fireplace wall was covered over with lath and plaster, and the fireplace opening was reduced in size. At that time, or perhaps during an even later renovation, a stovepipe hole was cut through the

paneling above the fireplace opening. Also during a later renovation, the archway was closed back in with a thin board wall with a set of double-doors.

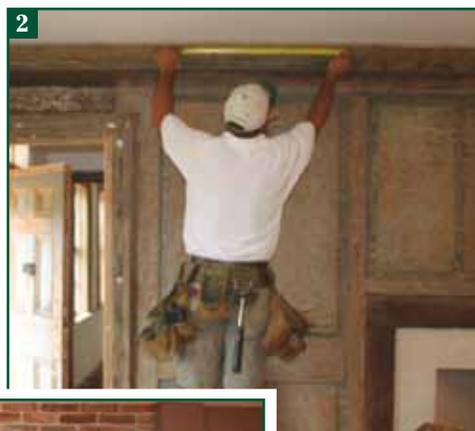
Reconstructing the room (Photo #2) — and all the other rooms in the house — meant letting the available original materials and the evidence found in or on those materials, and sometimes conjecture, dictate how each room should be finished. For example, the ghost markings and bazillion nail holes in the wall paneling gave clear evidence that the wall had been lathed and plastered over, and

the hole above the fireplace proved that the room was eventually heated by a stove instead of the fireplace. But the original paneling clearly indicated how large the original fireplace opening was. Where no

original trims were available, such as around the firebox, we went straight to an excellent sourcebook — Henry Kauffman's 1972 classic, The American Fireplace — for design elements, which we then custom-made in our workshop.

Although the archway was a later renovation, Tim & Cindy chose to retain the archway. All the wood paneling and trim were painted in a green milk-paint which closely mimics the original color.

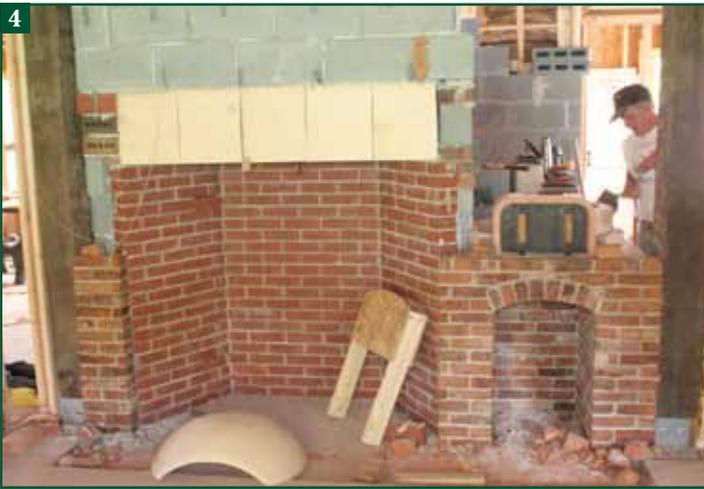
probable layout. The outer “face” brick (one of the “heaps”) are original to the house, but to meet code and ensure safety, the firebox itself is laid up with modern fire-brick. A bake-oven was original to this location so our mason, Sonny Weaver, laid in a modern pre-cast bake-oven — a major cost-saver since laying up an authentic squirrel-tail bake-oven is very labor intensive. (Photo #4)

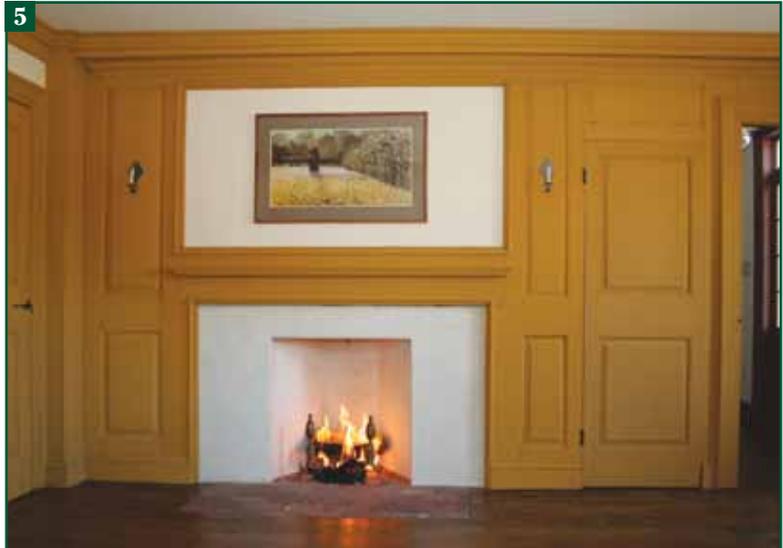
can see how the side and rear of the bake-oven dome is smack up against the Parlor fireplace, and the many flues are converging from all sides above him. It was just like the proverbial “stuffing 10 pounds of stuff into a 5-pound bag.”

Laying up these three back-to-back-to-back fireplaces plus bake-oven was no small feat for Sonny. (Photo #6) While laying up the firebox for the Parlor fireplace, you

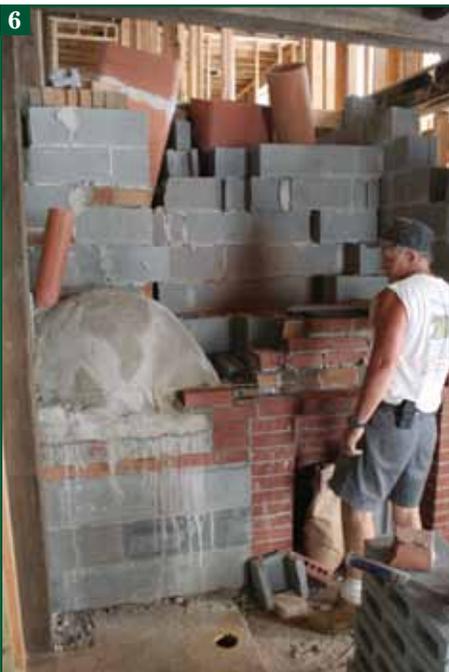
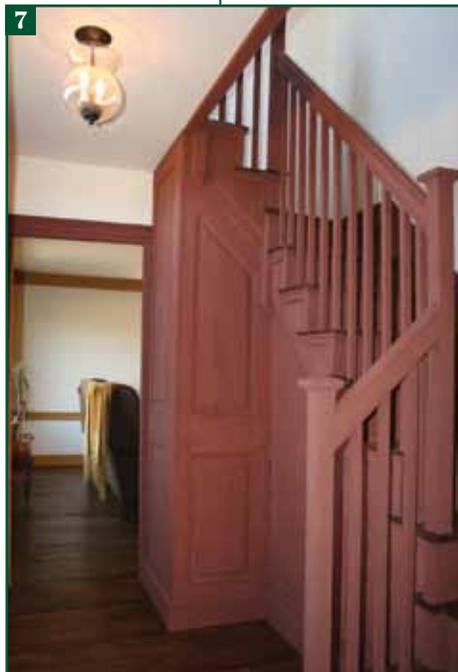
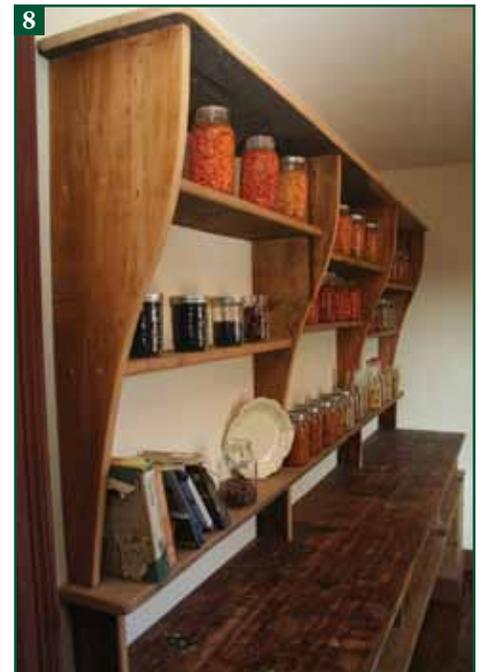
The very confined front entry, so typical of New England homes of that period, has a stairway (Photo #7) that proved to be a real jigsaw puzzle for the guys. All the original parts had been salvaged; however, the original configuration proved to be problematic. According to modern code restrictions, the stairway

was too narrow, the treads were too shallow, the rises too high, and the balusters too short. Because the entry space was very limited and there was no way it could be enlarged, and because the family generally would be using another stairway in the new addition, this old stair-

way was permitted to remain intact with just a few changes to get it closer to code requirements.

Since we had no means of lengthening the run of the stairway, the treads and risers could remain “as is,” which was a bonus in that we could retain the two-centuries-old wear marks that make an old stairway so endearing. However, we did have to reproduce new, longer balusters and newel posts.

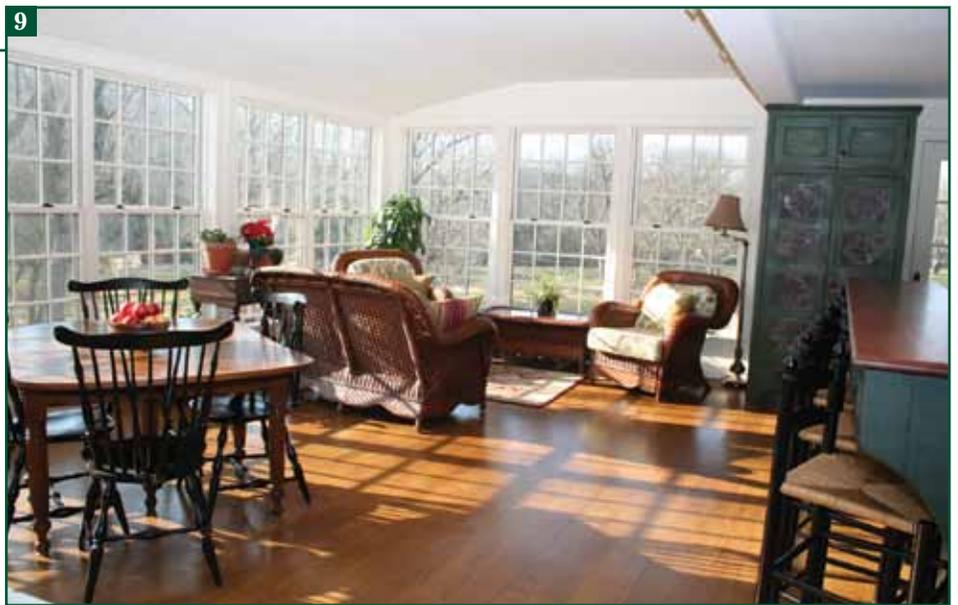
A large and inviting kitchen and gathering area make up most of the 1st floor of the addition. The sunroom area **(Photo #9)** takes in a broad vista of the surrounding fields, woods, and creek through entire walls of floor-to-ceiling windows. New random-width oak flooring provides a warm glow and long-lasting durability. The flooring is face-nailed like the flooring in the adjacent old portion of the house.

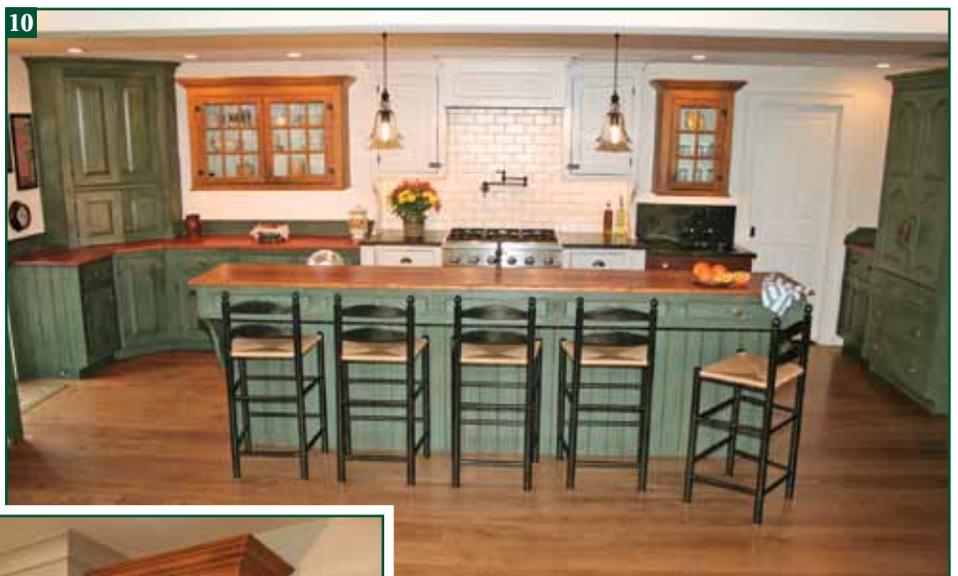
The kitchen comprises the other half of the area. **(Photo #10)** The cabinetry, by Jim Tshudy, is designed to look like a collection of old furniture, such as an old dry-sink, a corner cupboard, a pie-safe and others. All the cabinetry is constructed of cherry wood, is painted in a

3-color palate, and has a combination of cherry wood and soapstone countertops.

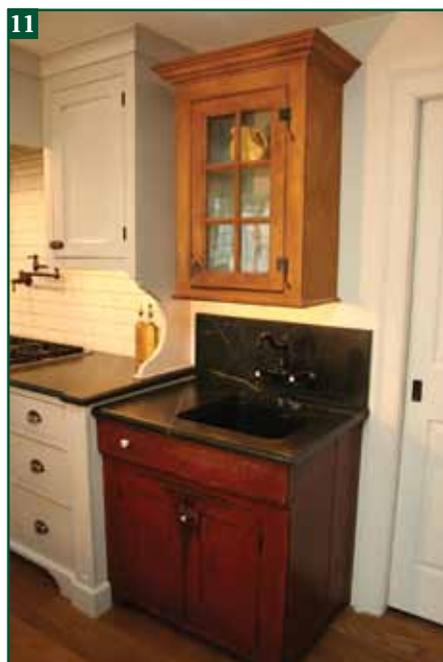
The small prep sink next to the stove masquerades as an old dry-sink with a furniture-style wall cabinet above. **(Photo #11)** The much larger work sink across the aisle is also made of soapstone. **(Photo #12)** This large sink is actually made of slabs of soapstone that have been fitted and bonded together to form the over-sized basin. The outer top edge has a gentle depression along its length as though it has seen years of use. The dishwasher is disguised behind cabinet door fronts. The hub of the kitchen, the stove-top, is a 6-burner semi-commercial cooktop with a convenient pot-filler set into the back wall. **(Photo #13)** Spice racks are fitted into pull-outs camouflaged as side pilasters in the base cabinet.

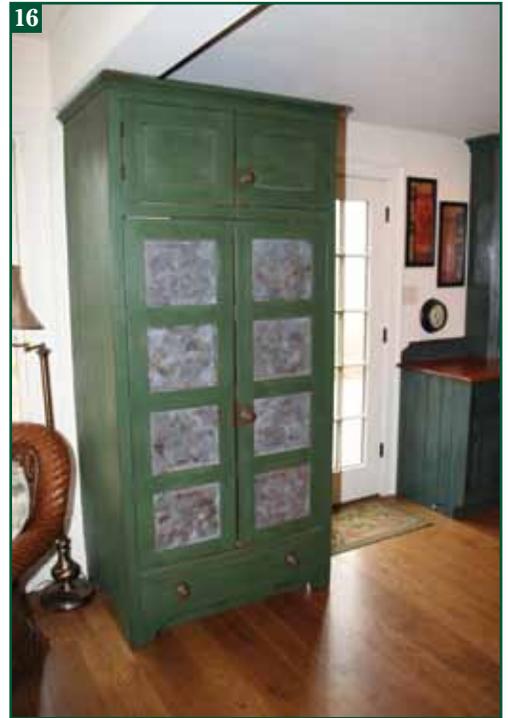
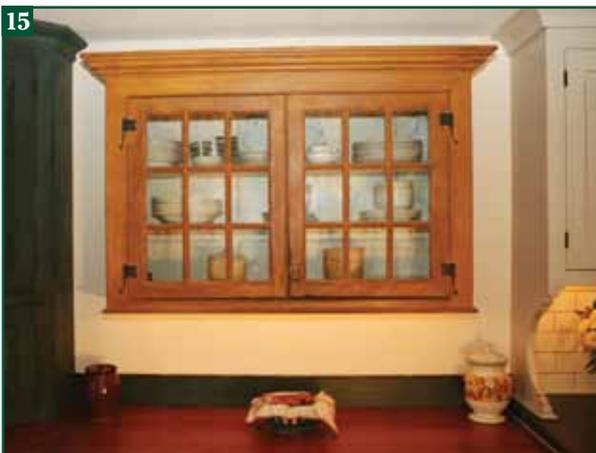
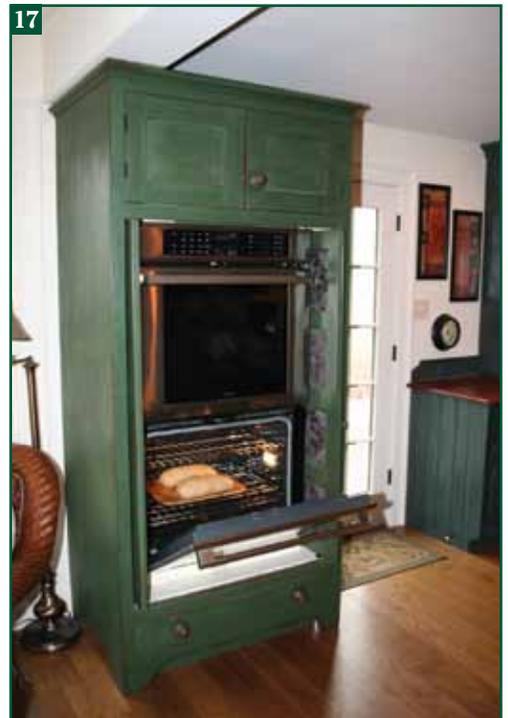
A tall “corner cupboard” (Photo #14) houses small appliances and the microwave oven, and another furniture-style wall cabinet (Photo #15) completes the cabinetry for the back wall.

Tall cabinets are stationed at each end of the kitchen; one (not shown) houses the refrigerator and appears for all the world to be an old, painted storage cupboard. The other (Photo #16) certainly looks like a free-standing, 19th-century, pierced-tin pie cupboard. But open the doors, which conveniently retract back into the cabinet, and you just may find pies....baking in the stacked double ovens! (Photo #17)
