SOLID AS A ROCK

Brick Hotel, the Appetizer Course

Restore 'N' More - Building Relationships & Providing Exceptional Craftsmanship Since 1987

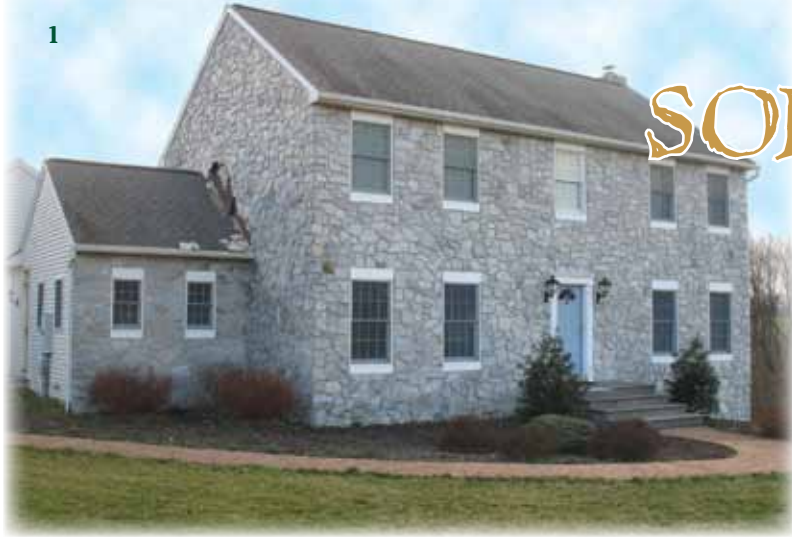
Steve & Mary Ellen are not new-comers to Restore 'N More. Although their house (Photo #1) is less than 15 years old, we had already completed some renovation projects for them. A couple years ago, Steve called Gary to tell him that he thought there might be some stones coming loose on the gable side of their house, right where the roof of the one-story addition connects to the main house. Because the stone façade on Steve & Mary Ellen's house is "stick-um" stone (real stone cut a mere one inch thick and applied to the structure on a bed of mortar), Gary initially assumed by the phone conversation that the problem would prove to be a failure of the flashing along the roofline, and it would be a relatively easy fix. Once he got up on the roof and saw first-hand the crumbling stone face, he realized that he and Steve & Mary Ellen were looking at a much bigger problem. (Photo #2)

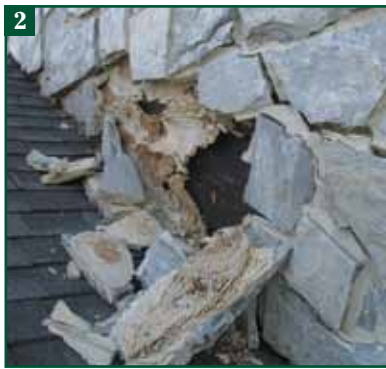
The most alarming part of what Gary saw there was the nearly non-existent wire lath. Wire lath is secured to the structure, then stucco is applied to that, and then the "stick-um" stone is embedded onto the wet stucco. The wire lath is, in effect, the foundation that secures the stucco and stone to the façade of the building. If it's deteriorated, there's nothing to keep the stone and stucco from eventually coming crashing down. And the evidence was already there that things above that roofline were falling apart.

Steve & Mary Ellen took the logical approach to fixing the problem: Remove the entire gable and front façades (they're holding their breaths on the other gable and rear façade), and do a total "re-do." Thankfully they chose that approach because, as our crew began the removal process (Photo #3), we discovered many areas of stone facing that simply fell off almost by breathing on them. On the other hand, some areas had to be worked off, with quite

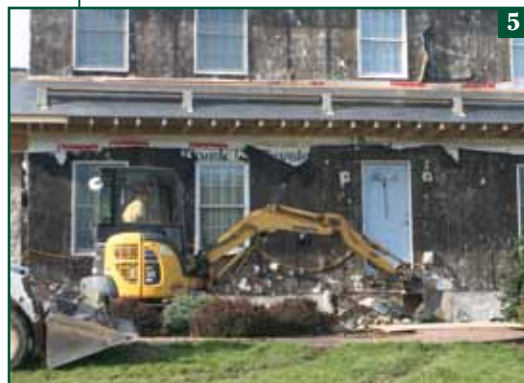
With everything stripped away (Photo #4), Steve & Mary Ellen had a "clean slate" to consider several options for how the new façade might be finished. They definitely wanted to add a pent eave across the front and wrapping around the gable. But they had choices of how to finish the façade above and below the new pent eave; stone or stucco below with log above, or stone below and log or wood siding above, or stone below and stucco above. They chose stone below and stucco above, and also requested that we change the window trims and the front door so they would have a historical feel to them.

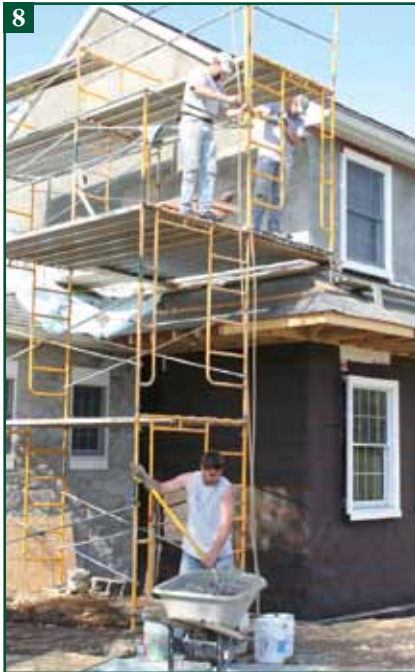
In the process they were very careful to protect the roof of the adjoining addition. (Photo #8)

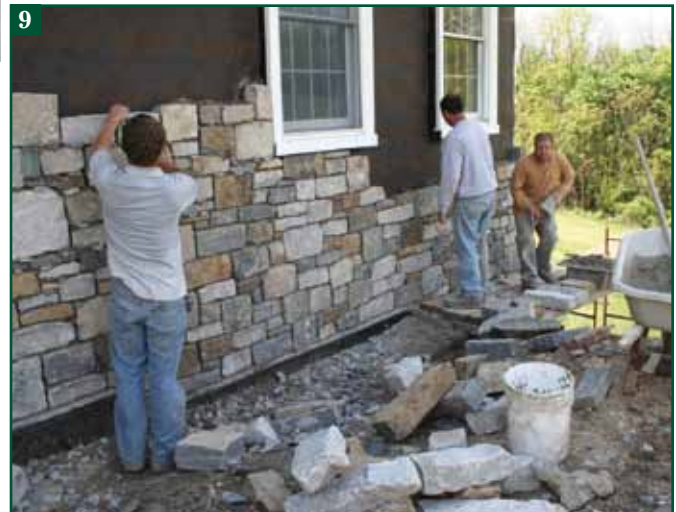
Once the stucco process was complete, the masons returned to lay up the lower-level stone façade. Using a blend of four colors of ashlar (square-cut) stone, they started at the farthest end. (Photo #9) By starting at the farthest end, Steve & Mary Ellen could decide, before the masons got too far along, if they wanted to adjust the proportion of stone colors.

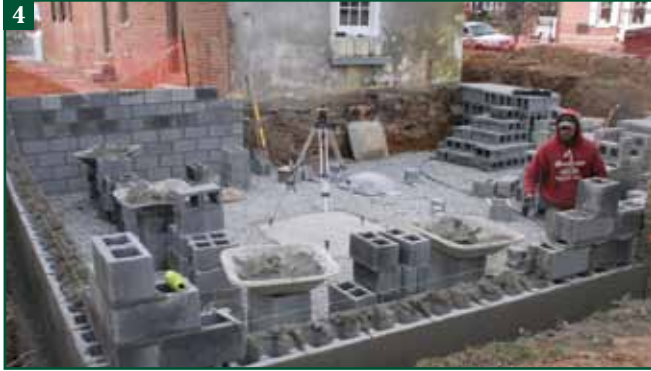
was clearing out the space between the two structures. **(Photo #1)** The space between the two buildings had been fenced to conceal the massive air conditioning units and electrical transformers. All this equipment had to be dismantled, electric supplies had to be temporarily re-routed, the vintage fencing was carefully salvaged, and the interior of Janvier Stable was also salvaged.

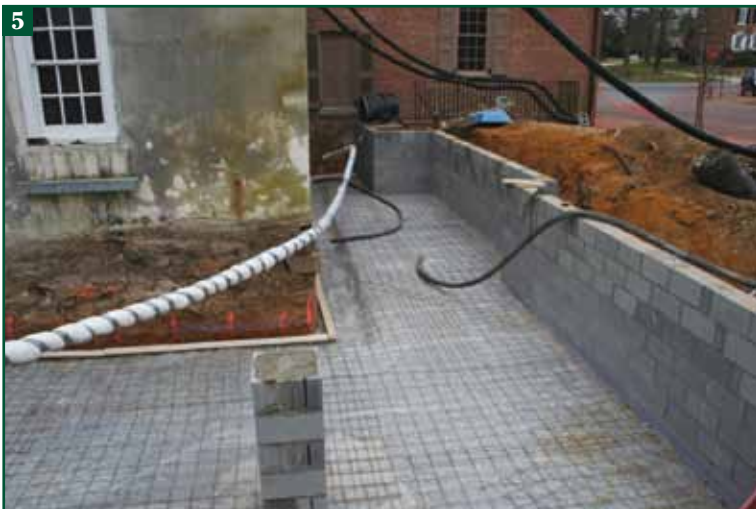
The cleared area now had to be excavated **(Photo #2)** for new foundations and a crawl-space beneath a

new connecting wing which would contain the working kitchen, ADA bathroom, and a new main entry for the restaurant. The stable floor was also dug down to create a crawl-space as well. We had to use extreme care working up against the two historic structures, literally undermining the old foundations in the process so that we could then reinforce what extant foundations were there. The original Hotel would become the dining area of the new restaurant, and the old stable would be transformed into a restaurant-grade walk-in freezer and refrigerator as well as a food preparation area.

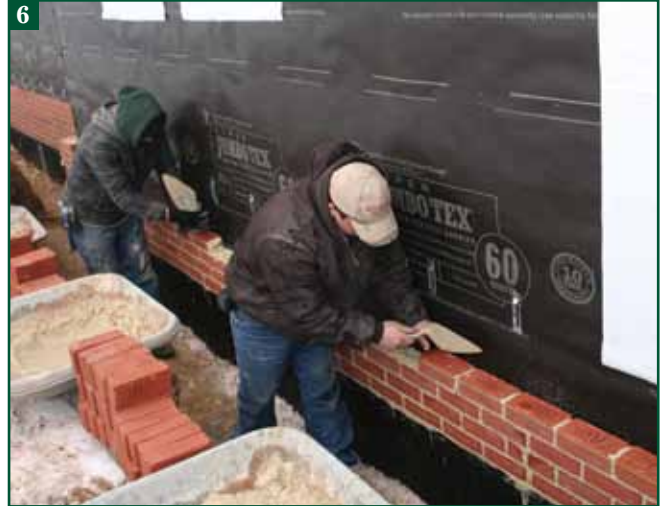
the rear door to the Hotel had to be removed. **(Photo #3)** The layout of the foundation and, therefore, the building design had to be “tweaked” to avoid hitting an existing well which had been overlooked in the design phase. (see vertical pipe to right of worker)
