Planting a New Kitchen

All God's Creatures

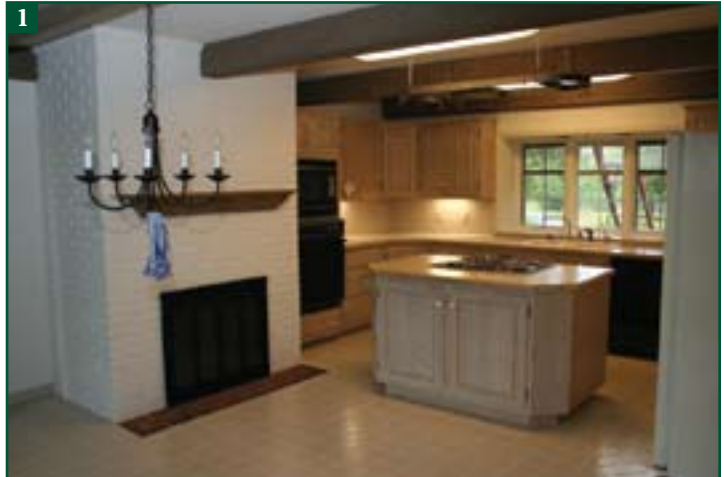
Although their kitchen was less than twenty years old, they were never quite satisfied with the layout. A massive brick fireplace had been built in the kitchen which overwhelmed the space. **(Photo #1)** It was a source of heat loss and they never used it, so they decided that was one feature they could happily live without. They also wanted to make the kitchen more "user-friendly" (efficient) and upgrade the appliances.

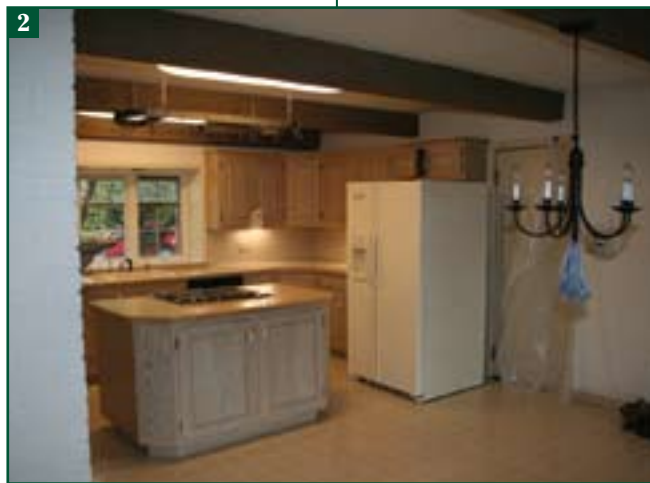
Prior to any removal or demolition, Dennis and the crew installed plastic at all the doors leading to adjacent living areas. **(Photo #2)** All access to the kitchen would be made through the door to the garage.

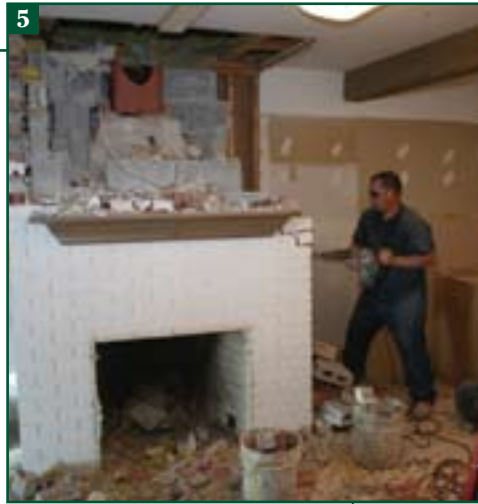
laid with Portland cement which is extremely hard so Rob had to resort to using a hammer gun to break it apart. It took several men several days to get it all down and out. It was at this point, (Photo #5) that Ann walked in and asked if we could re-use the wood mantle shelf elsewhere. Fortunately she walked in at just the right moment or it would have been hammered to pieces.

While they were rekindling old memories, the crew was busy inside. After all the cabinets were removed and some of the appliances set up elsewhere for Ann’s use during the project, Rob Horst, mason, began demolition of the massive fireplace and chimney. This 3' deep, 6' wide, all-masonry structure was rooted in the basement and went up through the kitchen, through the second floor, and then through the roof. And all of the debris, from the second floor level up, had to be removed by the bucket, up through the roof, and then down across the roof to the ground, being ever so careful not to damage the roof or the flower beds below. All that brick had been

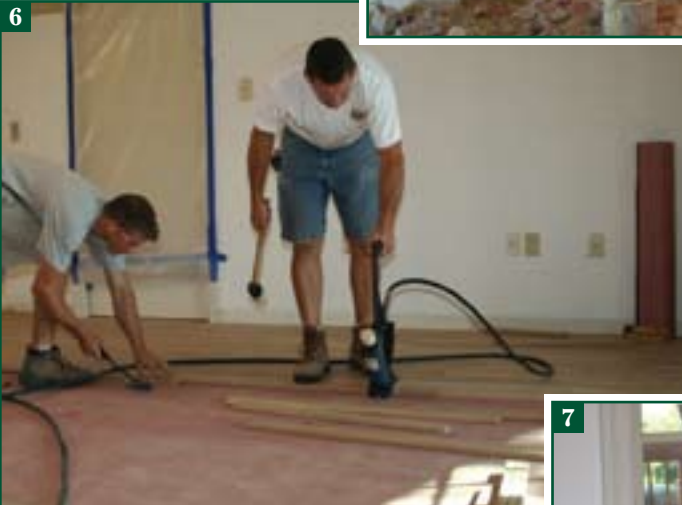
the room was wide open for the installation. Installing the flooring is a 2-man process. In this case (Photo #6), Cordell stays ahead of Dennis by getting the differing lengths laid out and tapped into place with a hammer. This is very intensive work as Cordell needs to be thinking quickly ahead to position the different lengths strategically so that joints are well staggered across the entire floor. There’s nothing worse on a wood floor than to see too many joints too close together.

Dennis is following close on his heels with the air nailer and secures each one. Back in the “old days,” the nailer was not air powered and had to be whacked really hard to set each nail. It was exhaustive work. But with these new air nailers, one tap of the rubber mallet, and the air compressor does all the hard work. (Don’t

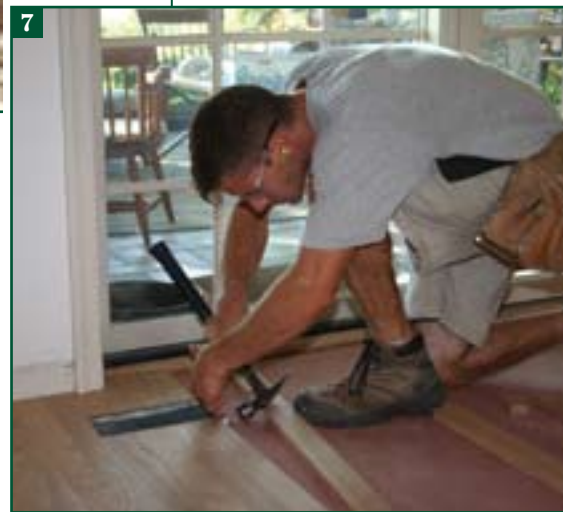
At each of the HVAC floor ducts, Cordell had to finely fit the flooring around each duct. **(Photo #7)** Because these duct openings had cast-iron Reggio registers fitted in them, the flooring pieces had to be routed out $\frac{1}{4}$ " so that the registers could finish flush with the floor and had to fit tight so that they didn't shift around in the opening.

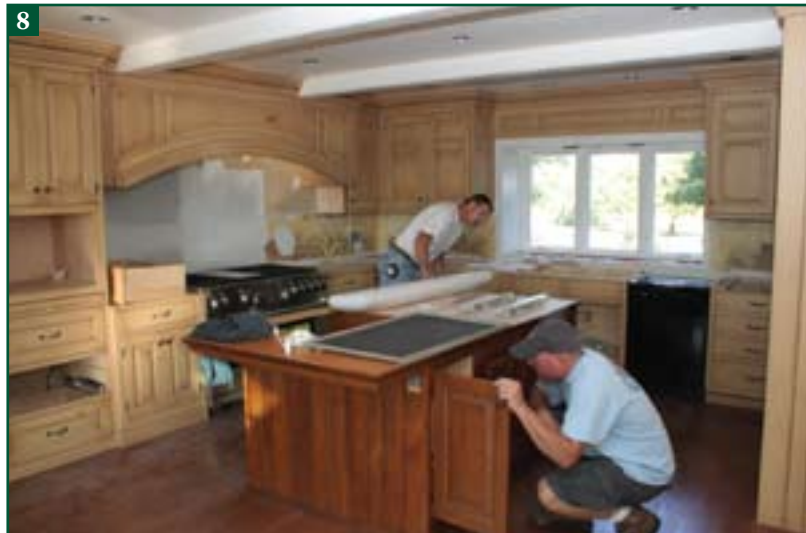
After the cabinets were installed, there was still plenty of work to be done. **(Photo #8)** The new wood flooring had to be stained and coated. Electrical and plumbing connections had to be completed. Appliances had to be installed and hooked up. The trims at all the doors and windows were replaced in the entire area. Even after all the trims were completed and nicely painted — all white — there was one glaring problem. The casing around the window, painted white like all the other window and door trims, looked out of place against the cabinets. So, Dennis stained and varnished the trim (using the same stain, antiquing glaze, and varnish from the very same cans used at the Premier cabinet shop) to match the cabinets. Dennis's artwork, seen in the final photo, makes the trim indistinguishable from the cabinets.

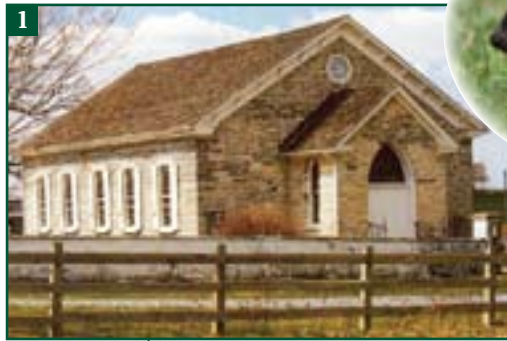
he was shocked to see what had happened to the lovely stained glass windows. Someone or something had vandalized many of the windows by gouging or chewing all around the wood sash (Photo #2), not to mention the

tionally sharp teeth. (Why else would we have the old saw, How much wood could a woodchuck chuck if a woodchuck could chuck wood?) So, it isn't too hard to imagine Chuckie Grundsau first clawing and gnawing the bottom of the door and, when that failed to gain him freedom, then climbing up onto the window sills and gnawing away at the "light holes." In that few days of captivity, he had chewed the door, the plinth blocks aside of the door, and six window sash. He was one determined bugger!

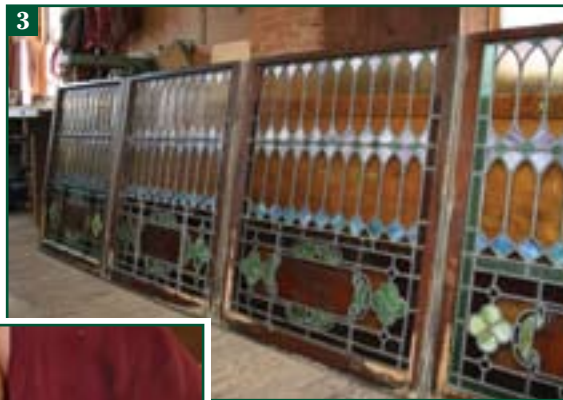
When Gary inspected the damage, he knew that the extent of the repairs couldn't be done on site; the sash would have to come back to the shop. So, the fellows carefully removed the six lower sash and solidly secured each window opening with plywood. They then wrapped each sash and packed them into Styrofoam to protect and stabilize the leaded glass. Once in the shop, each sash was given a closer inspection to determine the full extent of needed repairs. **(Photo #3)**

This errant woodchuck wasn't satisfied with chewing the flat rails or stiles of each sash. No-o-o, he had to gnaw on the molded profile. Because these windows are a century old, these profiles aren't standard fare that can be matched to modern-day trims. Beside the fact that the fellows had to custom grind a router bit to exactly
