Secret Garden

Country Classic

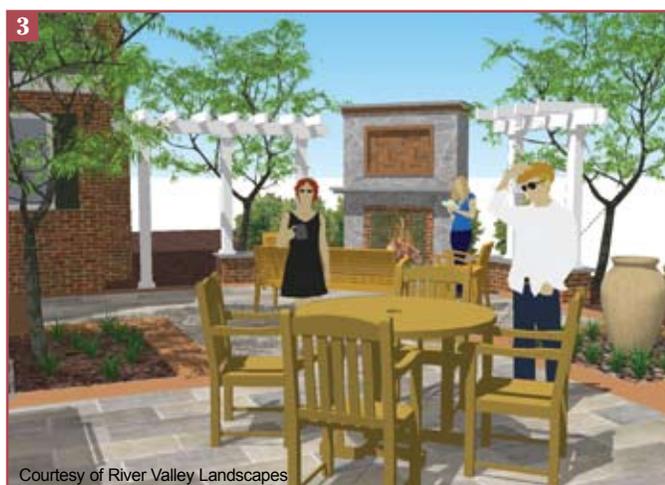
the back wall of the house, as well as the original concrete patio and all the sod. By using a small riding skid-loader (Photo #4), they were able to get all that demolition and removal done without disturbing the tree roots or compacting the soil around them.

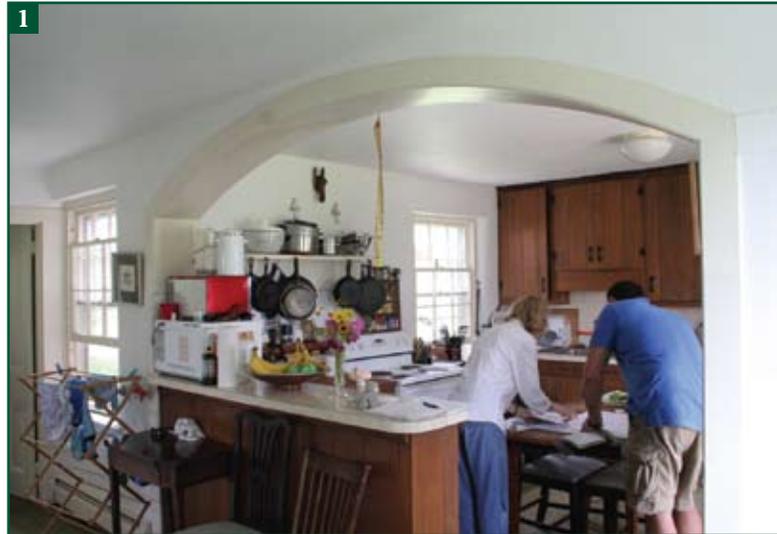
John & Celia's kitchen and adjoining dining room were both too cramped despite the large, open archway between the two areas. **(Photo #1)** The kitchen space was cramped and lacked sufficient cabinet storage, and the dining area was too small to comfortably accommodate a table and chairs and other activities of a young and growing family plus two dogs. Out of necessity, John & Celia had relegated the table and chairs to the kitchen area, even though it made that space even more cramped and inefficient. A cabinet peninsula separating the areas further complicated the issue, and yet without it there would have been almost no storage space. As it was, their microwave, toaster oven, and coffee maker had to be piled atop one another — pyramid style — on the peninsula because there was no other space for them.

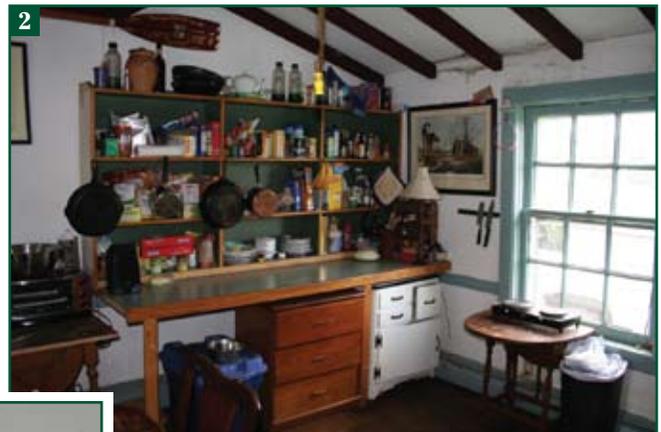
Once the project swung into full gear, John & Celia with the help of the Restore 'N More crew set up a temporary kitchen in an adjoining mud room. **(Photo #2)** Thankfully this project occurred during the summer months. John purchased a new grill so they could cook outside during the renovation. The crew removed the kitchen's double-bowl sink and dishwasher and made temporary hook-ups for them in the mud room. Water supplies were simple garden hoses hooked up to the

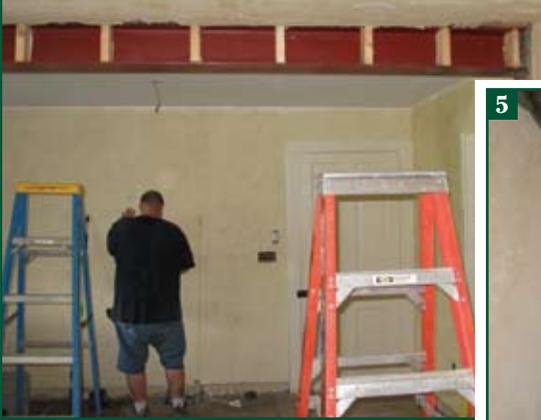
4

With John & Celia prepared, the Restore 'N More crew sealed off the work area from the rest of the house. Any demolition phase is dirty and dusty, but this would have more than the usual dust and dirt when the arch and wall were removed. The fellows removed the existing cabinets, **(Photo #3)** salvaging some for re-use in the adjacent laundry room. It was during this phase that the back of an old in-wall cabinet, accessible from the next room, was uncovered and that discovery led to an immediate modification of the new kitchen. (More on that later.) The arch and masonry wall were removed and substantially propped in preparation for installation of the new beam.

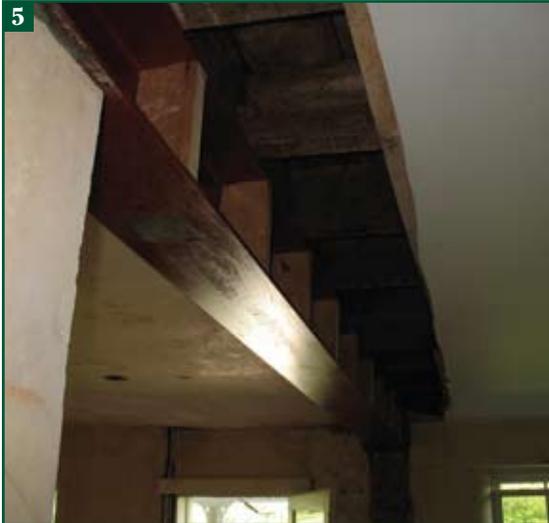
5

The new beam **(Photo #4)** bears on newly-laid masonry piers built flush to the existing walls. The 2nd-floor beam and joists can be seen resting on the new beam, the massive load now safely supported. **(Photo #5)** With the kitchen and dining area now completely gutted and the new beam in place, access to and re-working the mechanicals could occur. Two interesting things about this photo **(Photo #6)** can be seen in the center of the picture: the two green garden hoses snaking out the window which then travel over to the temporary

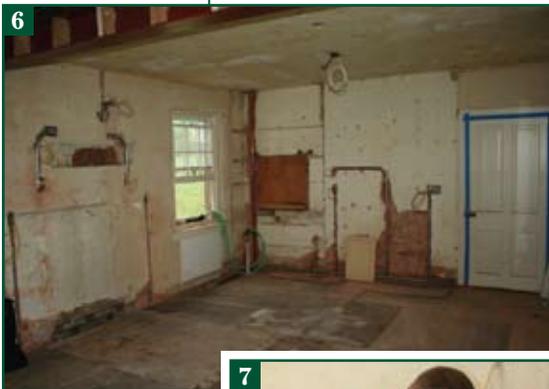
6

kitchen; and the brown boards to the right of the window, that is the back of the discovered in-wall cabinet.

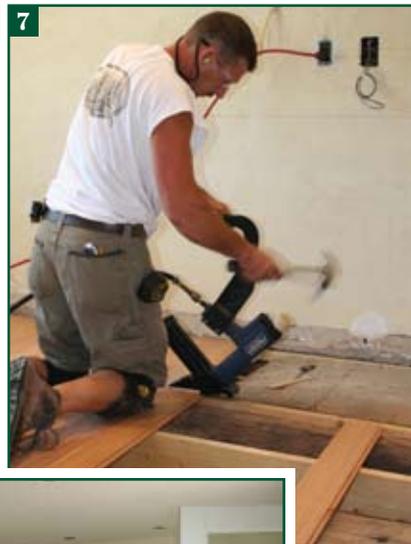
7

With everything removed from the area, including the old linoleum and sub-flooring, Dennis could then patch and repair what we knew to be old existing wood flooring. Half the floor was in good shape, but the other half — in the former dining area — was badly deteriorated. The floor system was also out of level by two inches over an eight foot span. So, before Dennis could replace or repair any flooring, he had to level the floor by adding “sisters” to the sagging joists. Then he could proceed with laying down new

heart-pine flooring in the former dining area, tooth-ing all that new flooring into the still-good wood floor of the former kitchen area.

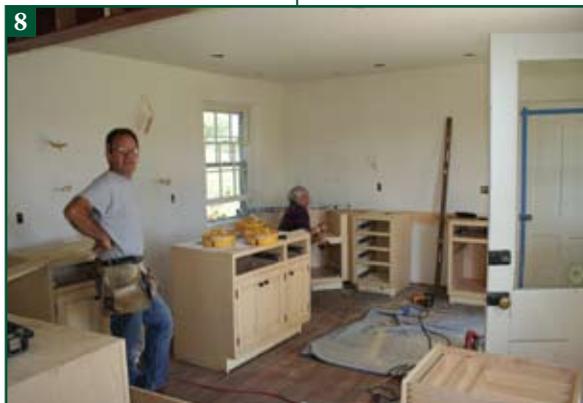
8

day”; the day the cabinets were delivered. **(Photo #8)** Blair and Harold, cabinet installers, now took command of the kitchen area.

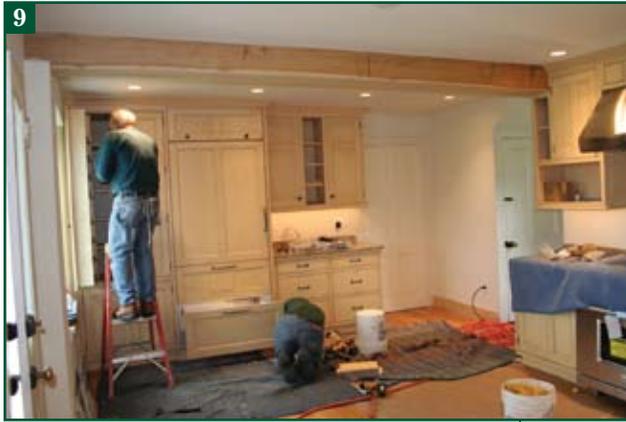
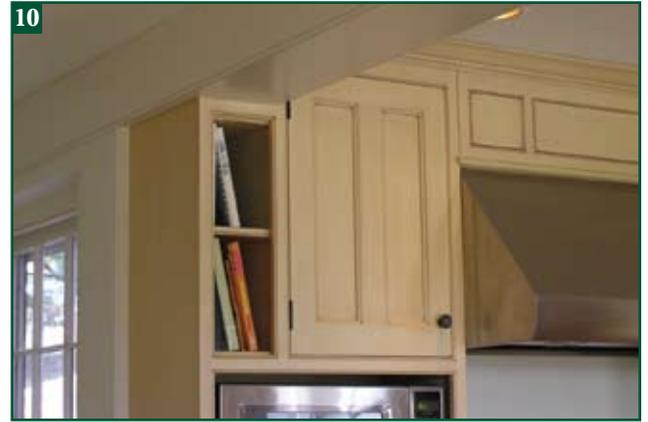
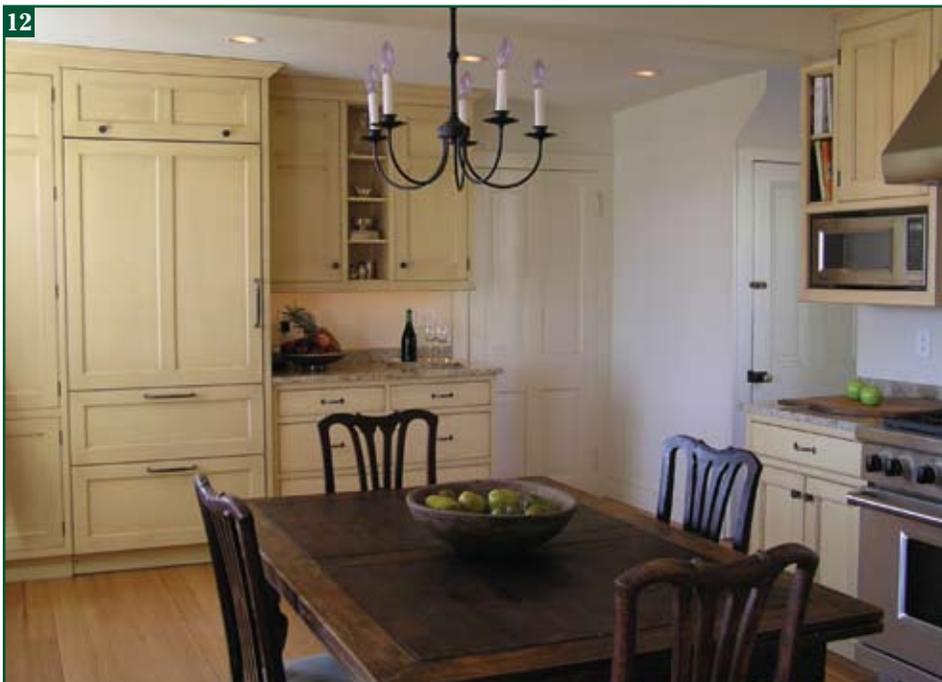
As the cabinets were being installed, Don and Dennis encased the new steel I-beam with beaded edge wood to make it appear like an original wood structural beam, fitting everything tightly to the walls, ceilings, and cabinets so that it appears original. **(Photo #9)** Because the ceilings in this house are not a full eight feet high, John & Celia chose to run the cabinetry all the way to the ceiling to give the ceilings the illusion of being “full height.” They also chose to have the new beam painted the same color as the ceiling so as not to draw attention to it, making it visually disappear. **(Photo #10)**

sink, adding bonus storage space to the kitchen. **(Photo #11)** And, a tall, double-door pantry flanks the built-in refrigerator. There is no lack of storage space now. The new kitchen, now measuring more than 13 feet wide by 20 feet long, gives John & Celia and their young family plenty of room to gather around the table. **(Photo #12)**
