Not too big, not too small, but just right

If Windows Had Ears...

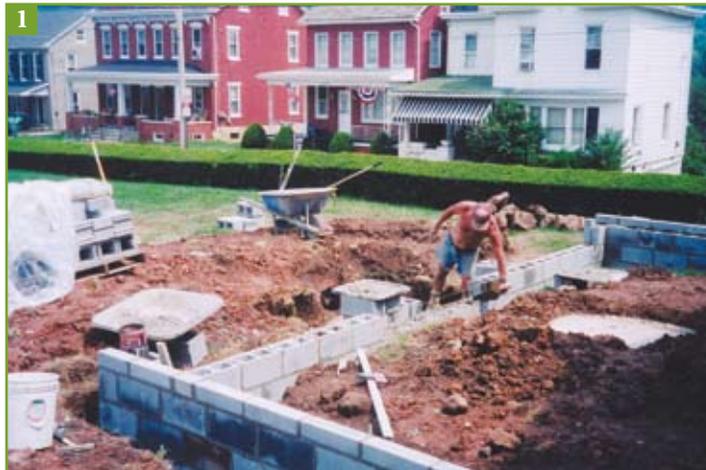
block walls up to floor level, and a large bump-out for the fireplace. **(Photo #1)** Rigid insulation was applied to the interior of the foundation walls to prohibit the cold passing from the ground, thru the block, and in to the inside slab which is their floor base. Mason Sonny Weaver laid the block walls up 8" wide from the footers up to slab height. Then he reduced the block size to 4" thick, creating a ledge around the inte-

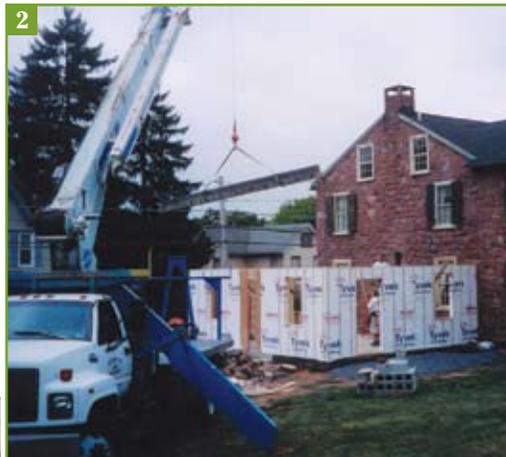
wood ceiling system. It just so happened that Dean, from Sylvan Brandt, had recently salvaged a suitable joist system from the old hotel in Ephrata. However, the summer beam — massive as it is — was not capable of supporting itself over the 20' span of the new addition. So, we bolted a 6"x6"x1/2" steel angle to the top side of the old beam. Threaded rods were run all the way through from the top side of the steel to the bottom of the beam, with nuts and lock washers attached below the surface of the beam. Then the holes

were plugged with wood plugs made from a piece of the beam that had been cut away. The grain of the plugs was aligned to the grain in the beam to disguise them completely. Then the new/old beam was hoisted into place with the help of a boom truck from Jack Garner & Sons who provided the steel beam. **(Photo #2)** The one end of

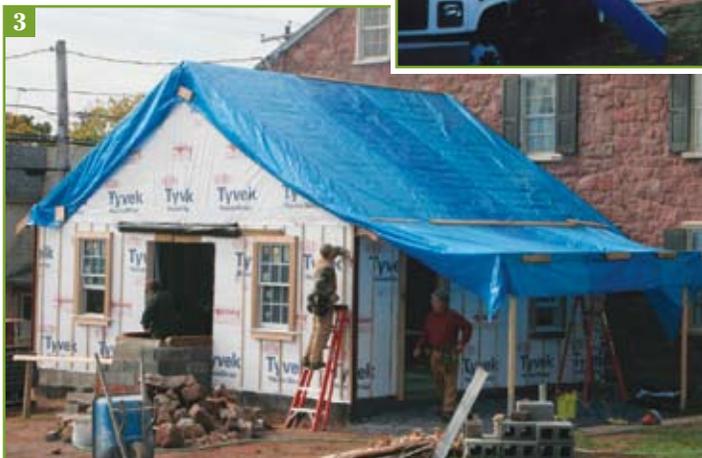
Beth Ann chose wood shingles for the new roofing, so we installed lath instead of plywood sheathing to the rafters. But, until the roofers could get there to install the wood shingle roof, that open roof system had to remain under plastic covers to prevent any water (rain) damage to the interior **(Photo #3)** — and this was during an extended rainy period. While we were waiting for the roofers, we installed the windows, roofline facias, and corner posts in preparation for siding, and Sonny continued his work at getting the fireplace started.

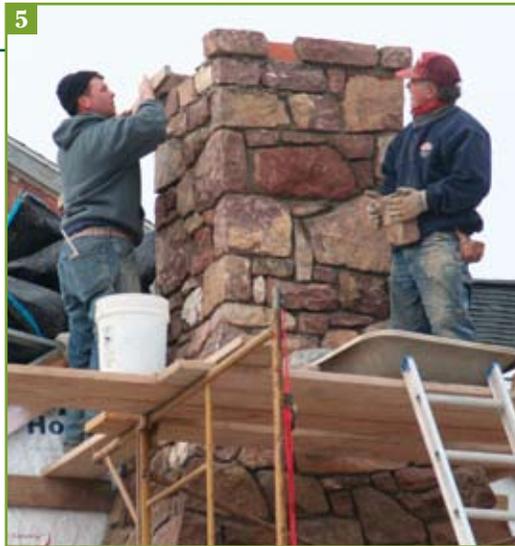
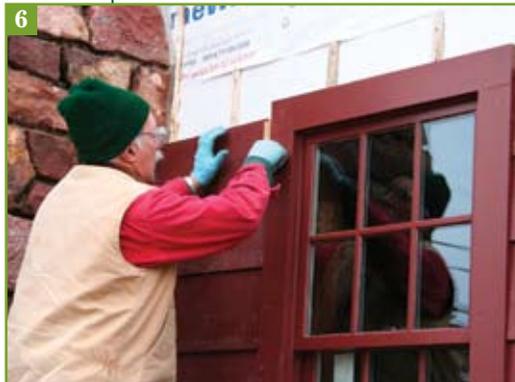
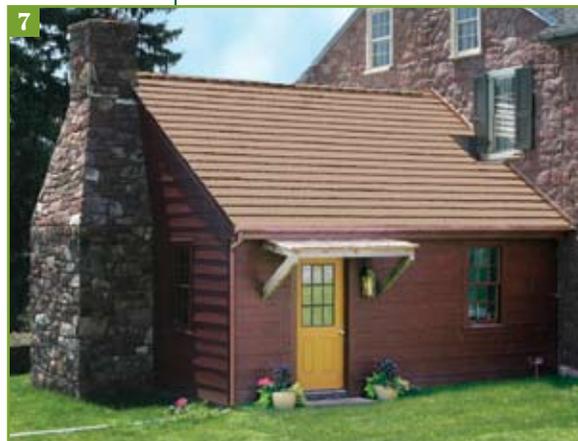
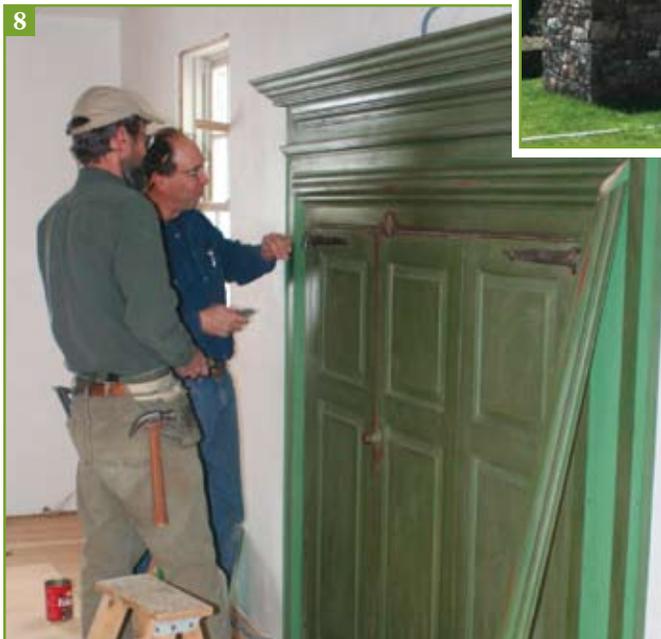
to the area. Well, Steve had just purchased 20 tons of old sandstone that had come from a nearby barn that "got in the way of progress." Because the stone was local, it matched the original house's stone perfectly. And, according to Gary's thinking, if you're going to do a stone chimney, make a statement with it. Sonny laid 14 tons of stone in this chimney, and did a masterful job at laying the stone — complete with dressed stone corners — in a way that it is pleasing to the eye. **(Photo #5)** One interesting point: Beth Ann mentioned that she particularly liked the stones that had pebbles embedded in them — which is often found in sandstone. Typically, a mason will avoid using them; but, in this case, Sonny laid several of them in the base of the chimney, just below eye

level, so that Beth Ann could see and appreciate them whenever she's out in the yard. Because the stones came from an old barn, many of them had whitewash still sticking to them. Steve and Beth Ann liked the look and decided to leave the whitewash on. It all came together to make this a one-of-a-kind chimney.

While Sonny was laying stone, the carpenters were installing siding on the front and back façades. The siding is random width (8"-10"-12"), shiplapped, cypress with a solid-hide stain the color of Madeira wine. All the siding on the gable end had to be scribed in against the irregularities of the stone chimney. **(Photo #6)** As we customarily do, the siding was installed over lath in order to provide air circulation behind the siding. Air circulation

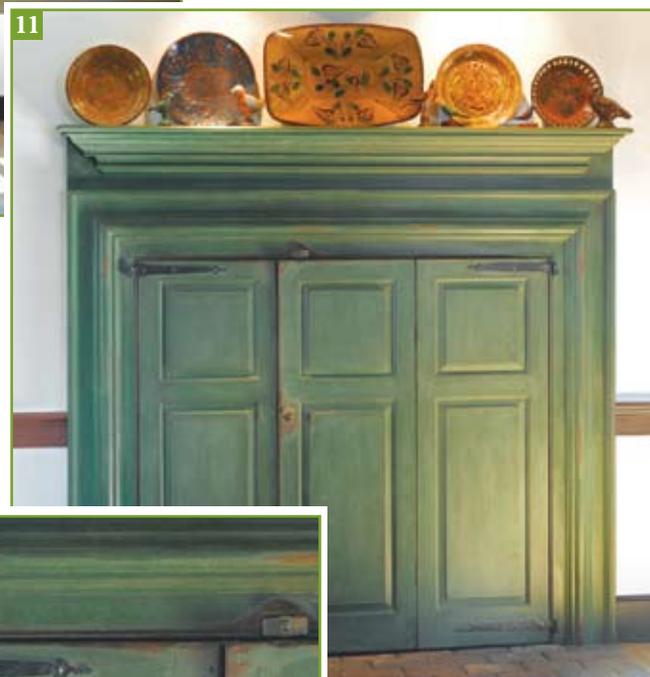
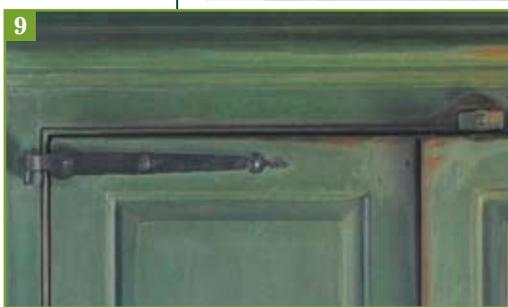
With her rough sketch in hand, Jim proceeded to create a phenomenal architectural piece that includes period strap hinges for the doors and a paint job that would blow anybody's sox off. **(Photo #8)** For Jim, the woodworking part of the process is the more fun and interesting part of his projects, but his paint work — which he considers the

least interesting — is phenomenal. The paint surface is a build-up of at least 6 layers of paint, crazed and

worn so perfectly that it could fool even the best. **(Photo #9)**

It's hard to decide which way the fireplace looks its best; with the doors opened or closed. **(Photo #11)** Either way, this spectacular fireplace (not too small and not too large) is the focal point of the room and warmly beckons visitors to come, sit awhile, and rest. ☺

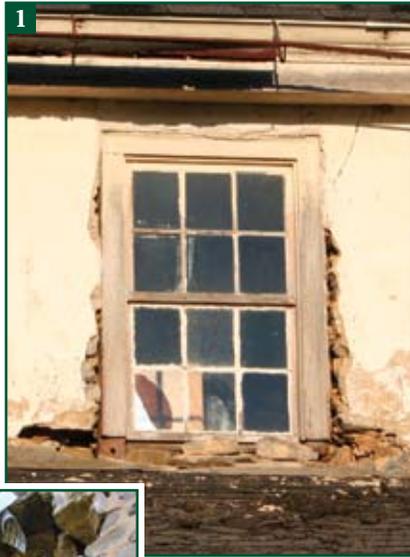
This second-floor window (Photo #1) is just one example of all the windows' deteriorated condition. If you look closely, you can see that the sill is completely rotted away leaving the side-leg tenons exposed, and the tenons are rotting away as well. The only way to repair old, rotted window frames like this is to remove the entire window frame from the stone wall.

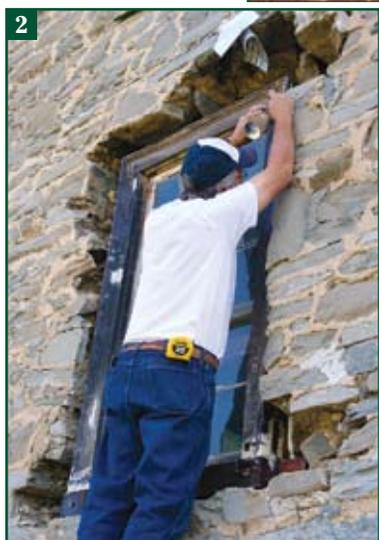
Removing an old window frame from a stone house isn't as simple as pulling out a few nails or screws. The process requires tearing out all the stone surrounding the window on all four sides (Photo #2) in order to expose the "ears" — the back tenon — on both the window head and sill. These "ears" are what get embedded in the stone wall as the walls are being laid up, and they

anchor the frame into the wall. Here, Jim Koller has one just about ready to pull out.

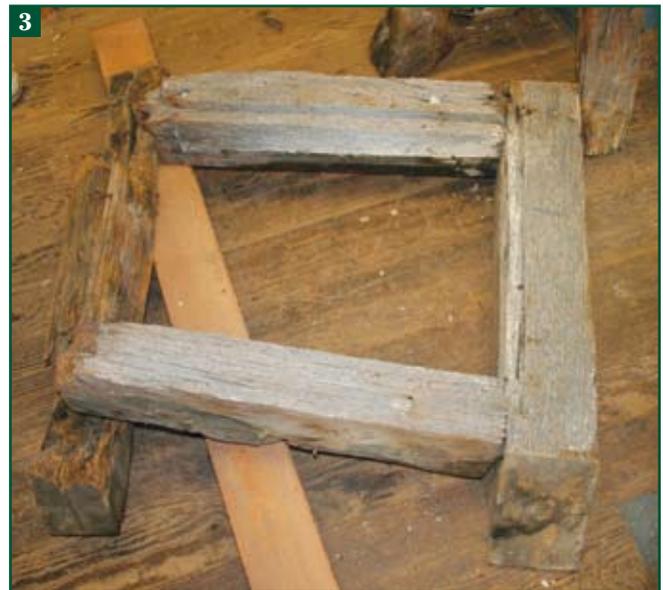
Once Jim had three or four window frames freed from the stone wall, he brought them back to our shop for the repair process. He repeated that process of removing, repairing, and re-installing until all seventeen windows were completed. One of the attic frames (Photo #3) shows the extensive damage rot had caused to the sills and tenons. The sill (the left side of the square) was completely rotted and hollowed out — so much so, that critters had made their homes inside of it. In an old repair, someone had covered the already rotted sills with aluminum, and the critters took up residence between the aluminum and rotted out "pockets" in the sills. As the picture shows, not only was the sill rotted, but the bottoms of the side legs were completely dozed off.

Reconstructing the bottoms of the side legs was the first step in the rebuilding process. Jim cut off the rotted portion at the bottom of the legs, including the tenon. He then "toothed" a new tenon into the cut end, and then wrapped the area with an aluminum form that was clamped and sealed around the cut end. He would apply white putty around the bottom of the form

in order to seal the form to the wood (Photo #4) before filling the form with liquid epoxy which sets up hard and knits itself to the wood fibers. This then hardened epoxy is impervious to water, which will help prevent any future rot, and makes for a far stronger bond than the original wood.

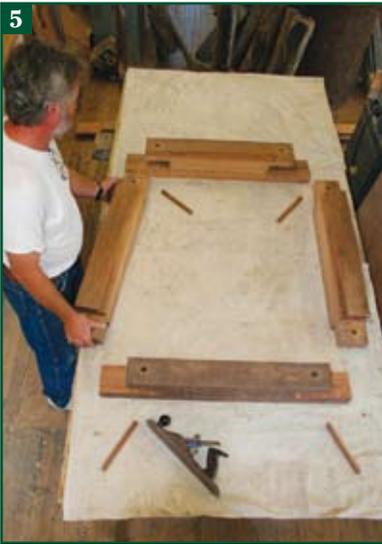
These new frames — as well as the re-built originals — are not nailed or screwed together. Rather, the originals were pinned together with tapered wooden pegs; and that's exactly how Jim reproduced them, also. (Photo #6) The pegs make a very tight connection; yet, if the frames ever have to be removed in the future, that future carpenter need only knock the pegs out to disassemble the frame.

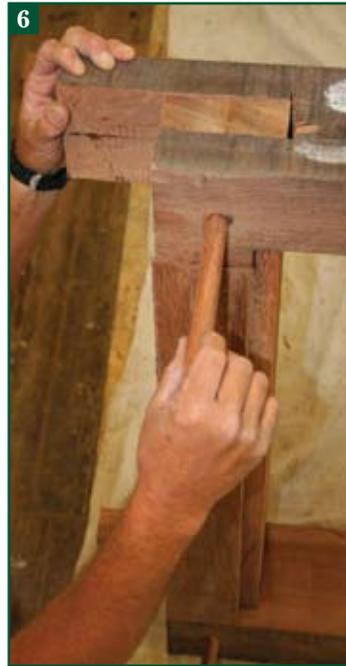
Once Jim had his next batch of frames re-built, he re-installed each one in its original opening. (Photo #7) Note the hardened white epoxy visible at the bottom of the frame's side legs, and the new sill. Now the mason can come back and re-lay the stone heads and sides, anchoring the frame (thanks to the "ears") back into the wall.
